C-27 SPARTAN MODIFICATION

FUSELAGE IMPACT SHIELD

MODIFICATION OVERVIEW

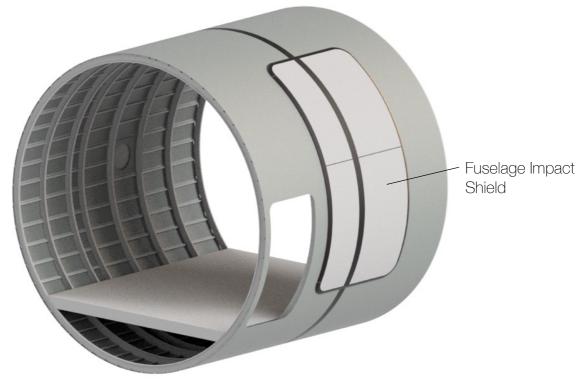
Figure 1: C-27J Fuselage Impact Shield

The C-27J Fuselage Impact Shield is designed and manufactured in Australia.

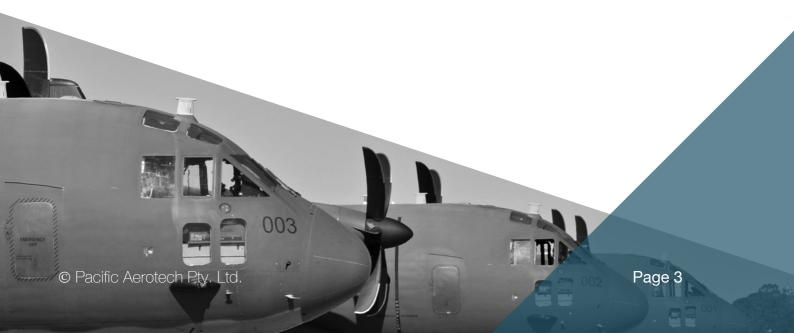
Figure 2: Unprepared Runway Operation

- Propeller Shedding Ice. Propeller de-ice system regularly cycles to remove ice that has formed. The ice fragments can impact the fuselage skin at 135 m/s.
- Unprepared runway operation.
 Operating on unsealed runways may result in stones or other debris thrown onto fuselage skin from propeller at a velocity of 220 m/s.
- Vulnerable fuselage skin. Fuselage skin is thin gauge (1mm) which doesn't resist impact.

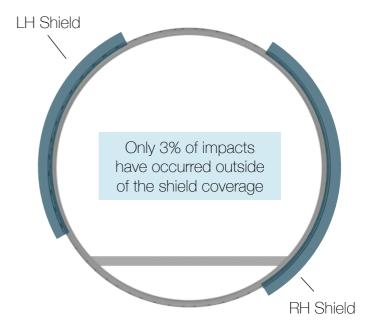
Figure 3: Offset shield design

Two interlocking hybrid composite shields are installed each side of the fuselage:

- LH coverage: STA 6580 to STA 7900, STR 5 to STR 17.
- RH coverage: STA 6580 to STA 7900, STR 10 to 23.

The shields are moulded to match the profile of the fuselage skin and are constructed from:

- Innegra (HMPP) which provides the shield with high impact resistance (similar to Kevlar except it is hydrophobic).
- Fibreglass, provides the shield with a galvanically compatible interface and a light and durable exterior.
- Aeromesh, protects the shield from lightning strikes.

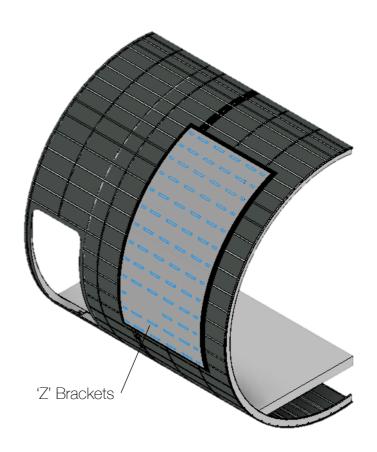
The shields are stood off the aircraft skin with aluminium 'Z' brackets. The brackets pick up on existing stringer rivets, meaning no new holes are drilled into the fuselage skin.

A custom silicone seal is installed around the perimeter of the shield to prevent chaffing with the fuselage skin. The seal also prevents airflow entering beneath the shield.

Shield protrudes a maximum of 25 mm from the skin

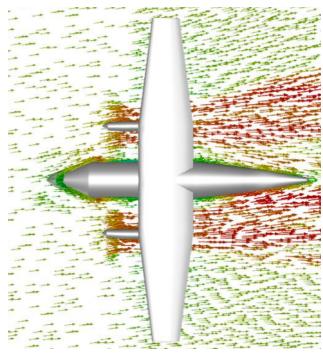
Figure 4: CFD Analysis - Sideslip Load Case

- Aerodynamic effect of fuselage impact shields shown to be negligible.
- Cases analysed:
 High speed (260knots, α=2°)
 Low speed (130knots, α=13°)
 Severe sideslip (260knots, β=15°)
 Sideslip para-ops (130knots, β=8°)

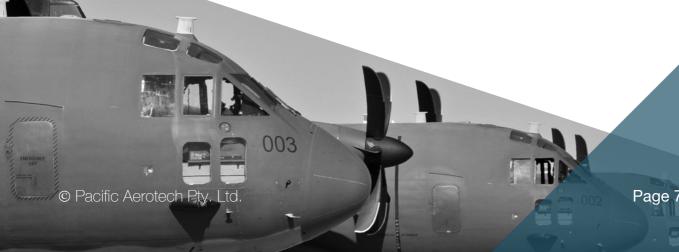
Impact testing with equivalent energy from both ice and stone impacts have been conducted to optimise protection and weightsavings.
